# Exit Gate-Arm Fail-Safe Down Test

Greensboro, NC  
Hilltop Road & Mackay Road

NC DEPT. OF TRANSPORTATION  
RAIL DIVISION

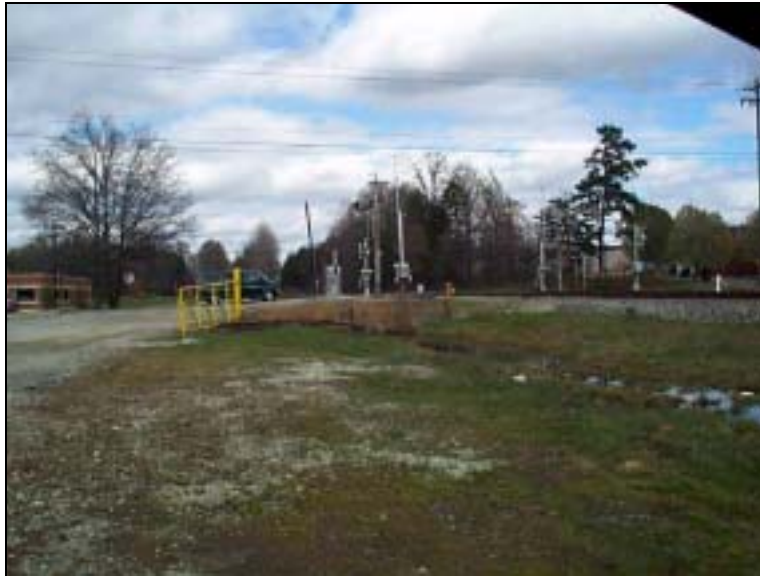
Figure 7.1 – Mini-Van Stopped Behind Stop Line at Mackay Road (Test Sequence X)

- a. The first vehicle in the traffic queue to approach a horizontal exit gate-arm **always** stopped behind the stop line. Figure 7.1 shows a green mini-van stopped behind the stop line at Mackay Road (e.g. test sequence X). The southeast exit gate-arm is horizontal.

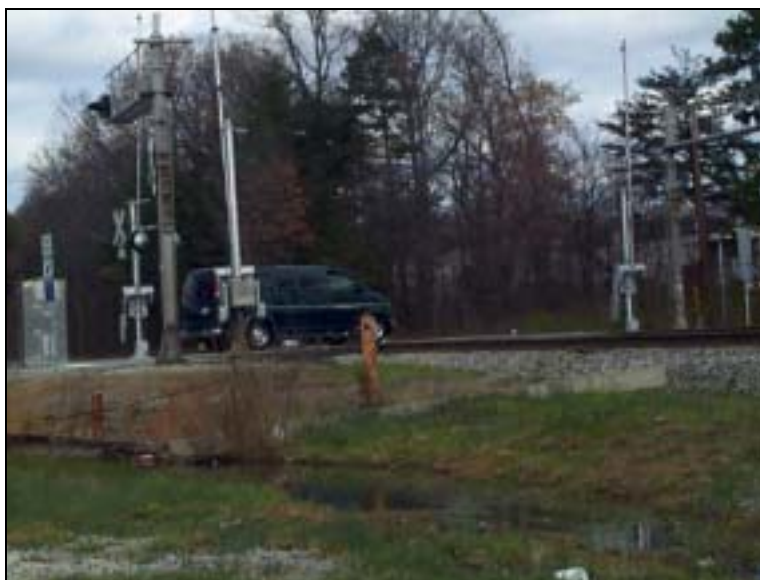
Figure 7.2 – Mini-Van Violating Horizontal Exit Gate-Arm at Mackay Road (Test Sequence X)

- b. On average, a motorist waited 73 **seconds** before violating the horizontal exit gate-arm. Figure 7.2 shows the green mini-van from figure 7.1 violating the horizontal exit gate-arm after waiting 155 seconds.

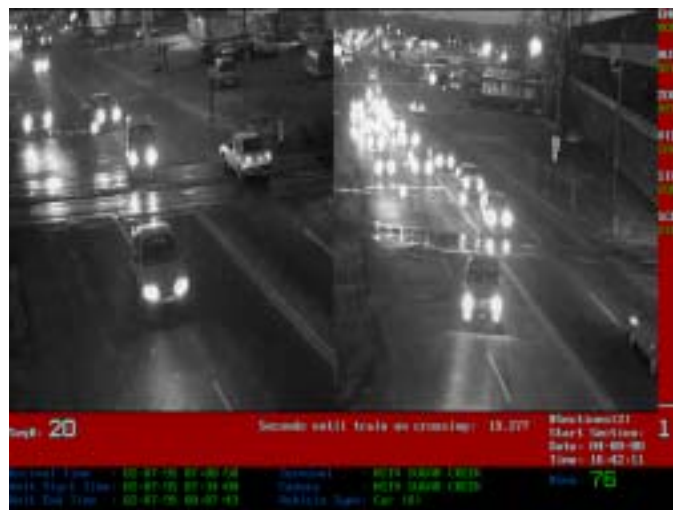
**Figure 7.3 – Motorist Violating Gates at Sugar Creek Road with a Train Approaching**

- a. During the exit gate-arm fail-safe up tests, 14 motorists drove around the entrance gate-arms. After the first vehicle went around a gate-arm, the other motorists assumed the intersection was safe so they proceeded around the gate-arm (i.e. "monkey see, monkey do" driver behavior). Under this situation, the probability of a collision is high.
- b. Figure 7.3 illustrates the possible exposure to collision presented by an exit gate-arm fail-safe up design. It shows several motorists violating the gate-arms (e.g. "monkey see, monkey do" driver behavior) at Sugar Creek Road during a false activation. The train was 19 seconds from the intersection and motorists were still going around the gates.
