the ENGINEER'S PERSPECTIVE

A Final Report: RailView

SEPTEMBER 2010

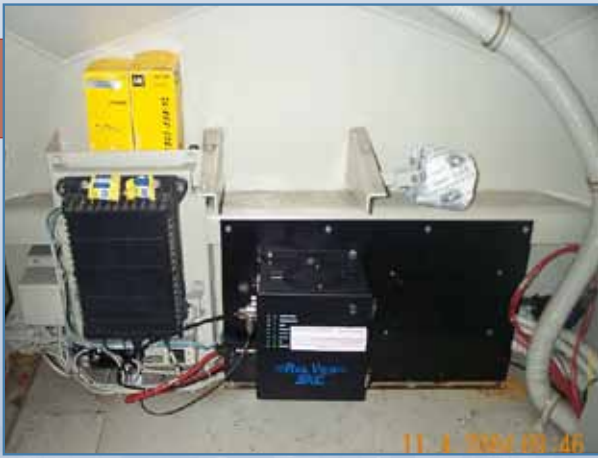
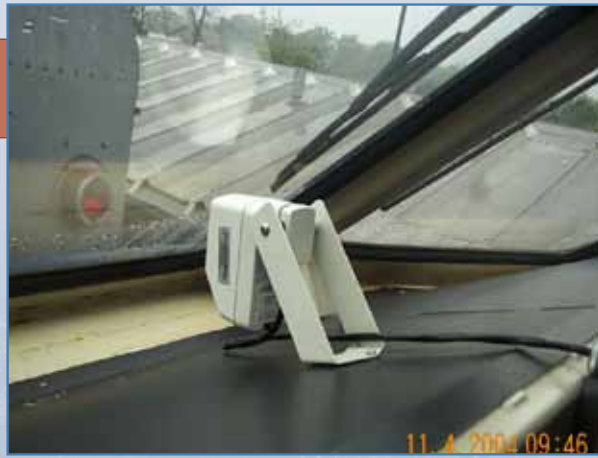
The NCDOT uses five RailView recorders on a rotating basis. One recorder is installed on each locomotive at all times. Two recorders serve as replacement units. In the event of an incident, the recorder is pulled from the engine and replaced with a reserve recorder. The recorder is run through a diagnostic check to confirm its proper working order at the time of the incident. After diagnostics, the video is downloaded and analyzed by NCDOT. In addition to digital video, RailView also detects train speed, reverser position, horn annunciation, and emergency brake activation. For the NCDOT application, the RailView data recorder is mounted in the short hood, with the camera being installed on the dash of the locomotive at the bottom of the windshield. The microphone is located behind the engineer cabin but is still able to detect the train horn and bell. The photos on the following page show the mounting locations for the recorder and camera.

RailView is hardwired into the locomotive to detect reverser position and horn and emergency brake activation. The train speed is determined by connecting to the axle generator and measuring the pulses-per-minute created by the generator. Time and date are set within the recorder unit using the US Naval Observatory Master Clock.

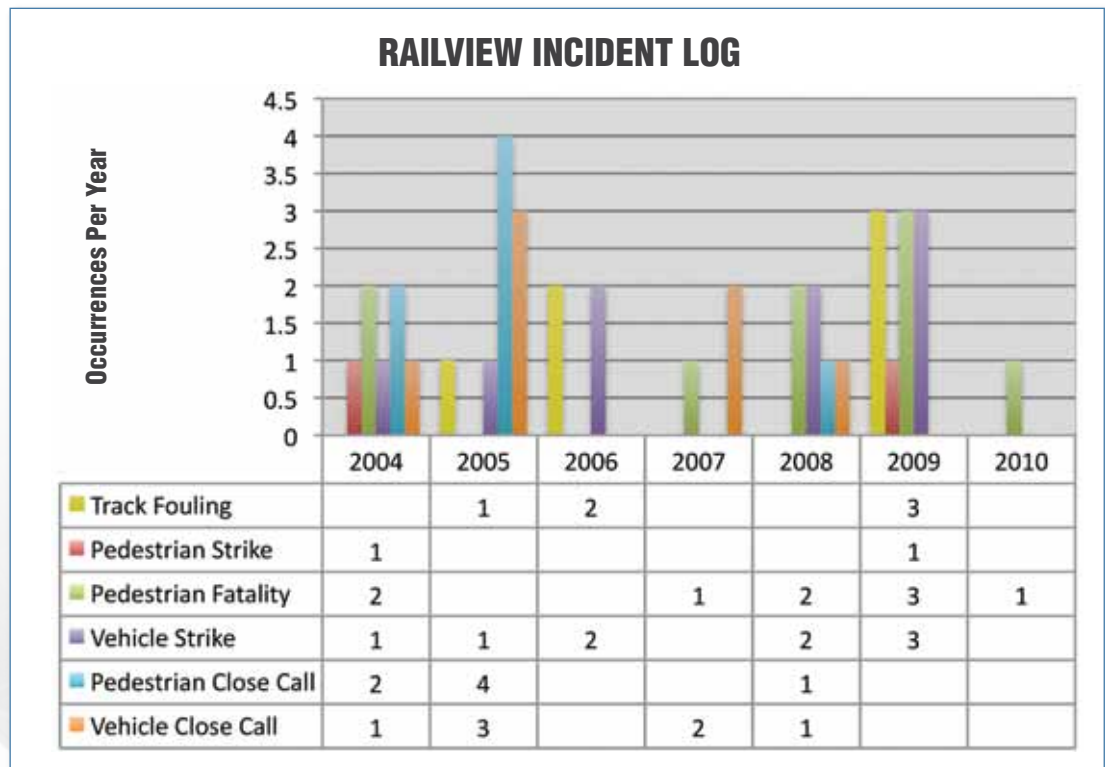
INCIDENTS RailView has logged 40 on-track incidents since 2004. To date, nine fatalities, 14 close calls, 11 collisions, and six track fouling events have been recorded on the *Piedmont*. The table below shows the year-over-year frequency of each type of incident that occurred.

Additionally, RailView has also recorded two late signal activations and one stop signal overrun during corridor monitoring.

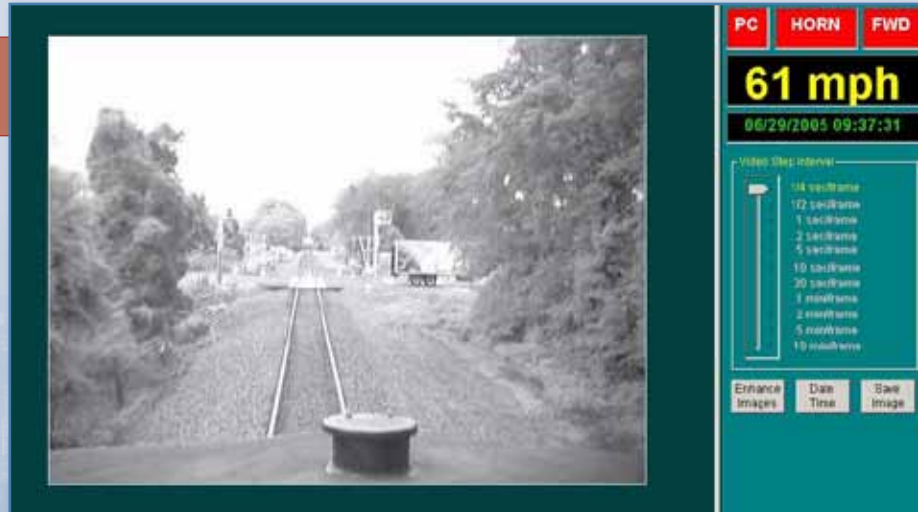
TRACTOR-TRAILER CLOSE CALL Shamrock Road Crossing No. 715 328G

JUNE 29, 2005 // The southbound *Piedmont* caught a tractor-trailer running under the exit gates of this four-quadrant gate protected grade crossing. The engineer threw the emergency brake as a precaution in case the truck did not clear the crossing in time.

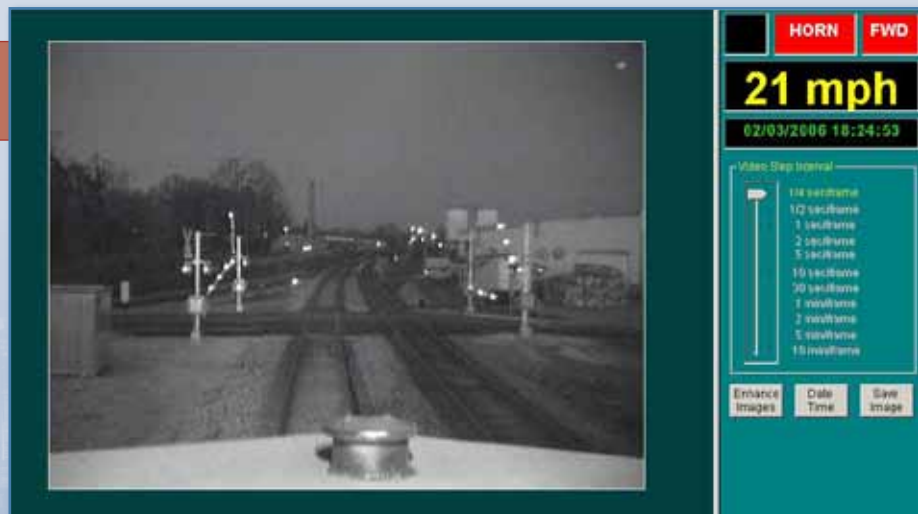
LATE SIGNAL ACTIVATION Henderson Street Crossing No. 715 301X

FEBRUARY 3, 2006 // The northbound *Piedmont* just left the Salisbury station when it caught the late activation of the crossing warning devices. As a result, signal activation timing was adjusted to allow proper warning time of an oncoming train.

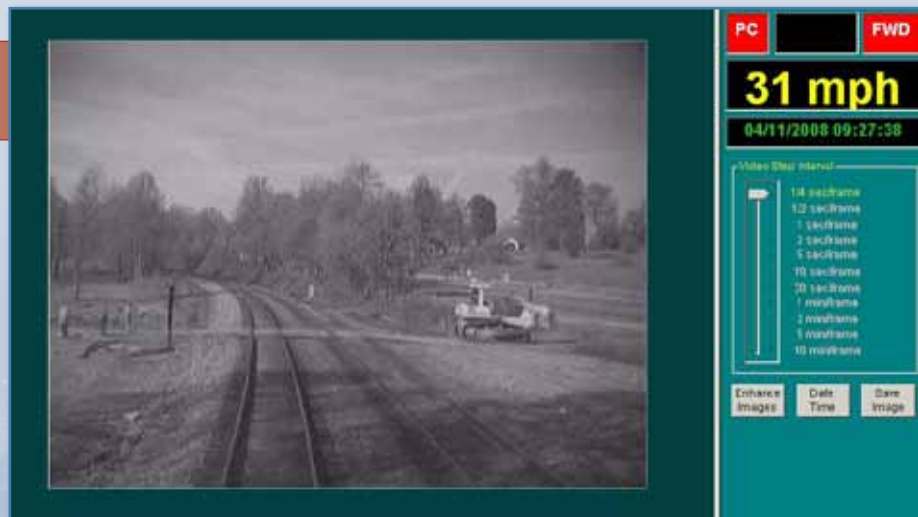
CONSTRUCTION CREW CLOSE CALL
Private Crossing No. 904 231G

APRIL 11, 2008 // The southbound *Piedmont* had just crossed the Yadkin River Bridge when it encountered this construction crew working in the railroad right-of-way. The crew did not clear the tracks fast enough, and the engineer engaged the emergency brake.

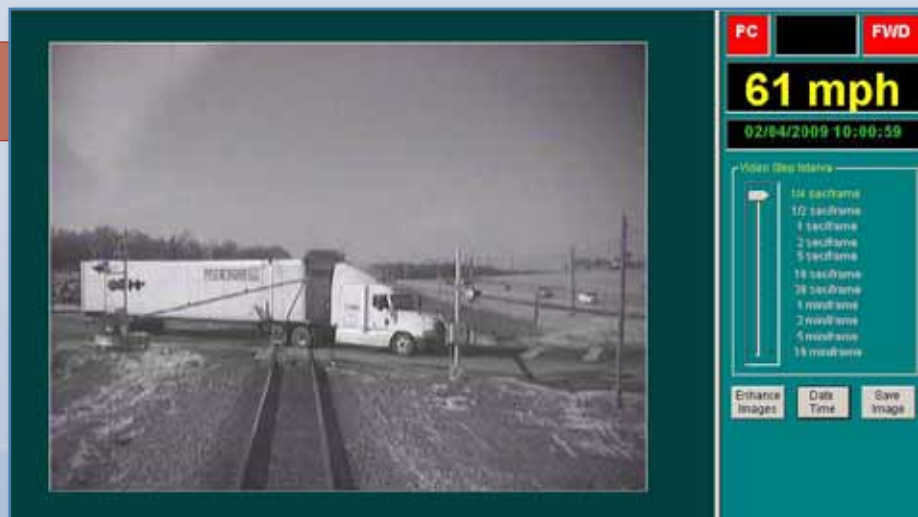
TRACTOR-TRAILER COLLISION
Pharr Mill Road Crossing No. 715 325L

FEBRUARY 4, 2009 // The southbound *Piedmont* struck this tractor-trailer as it failed to yield to warning signals at a four-quadrant gate protected crossing in Harrisburg.

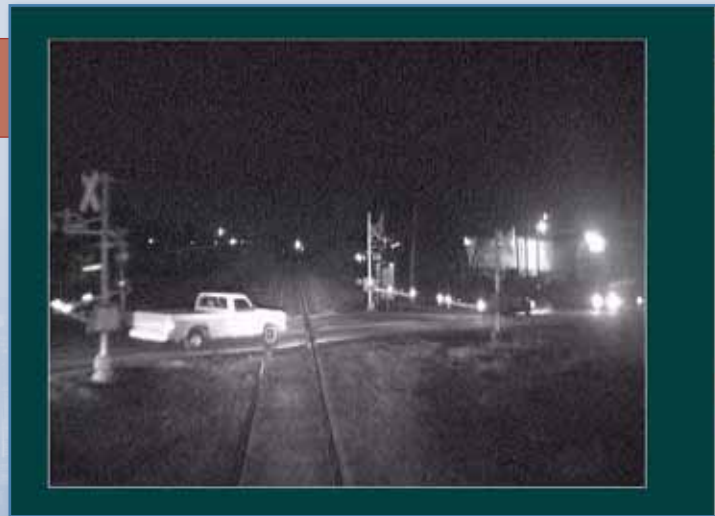
Washington Street Crossing No. 735 448C

VEHICLE COLLISION

February 27, 2009 // The northbound *Piedmont* struck this passenger vehicle in Graham after the signals activated with the truck in the crossing. Instead of proceeding through the crossing, the driver made a failed attempt to back away from the crossing.

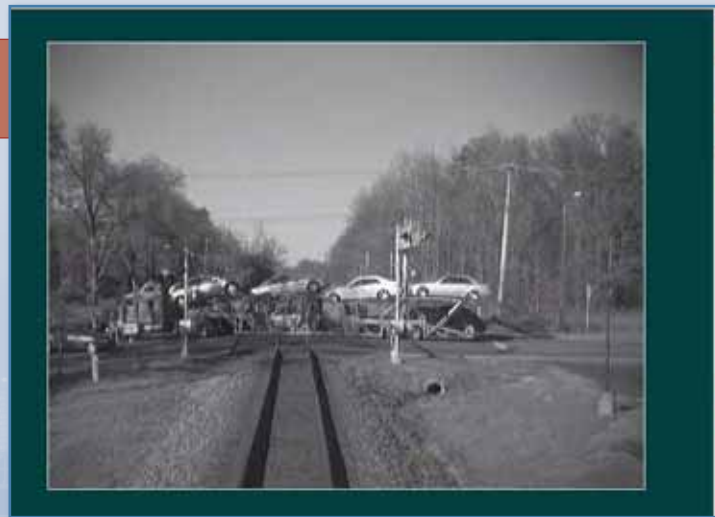
Newell Hickory Grove Road Crossing No.715 348T

CAR HAULER COLLISION

March 20, 2009 // The northbound *Piedmont* encountered a bottomed-out car hauler in Charlotte.

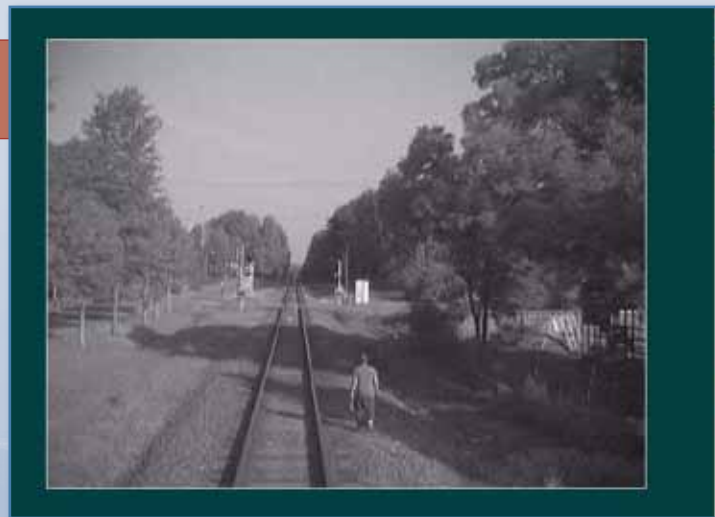
Milepost 14.46

PEDESTRIAN CLOSE CALL

June 3, 2009 // The southbound *Piedmont* grazed this pedestrian near the Joyner Street Crossing in Gibsonville. The pedestrian suffered only minor injuries.
